How to Read Steel Ladle Wear – 30 Years of Experience (Good, Bad and Ugly)

Thomas Vert*,
Independent Refractory Expert

1. Vertical Cracks in Working Lining

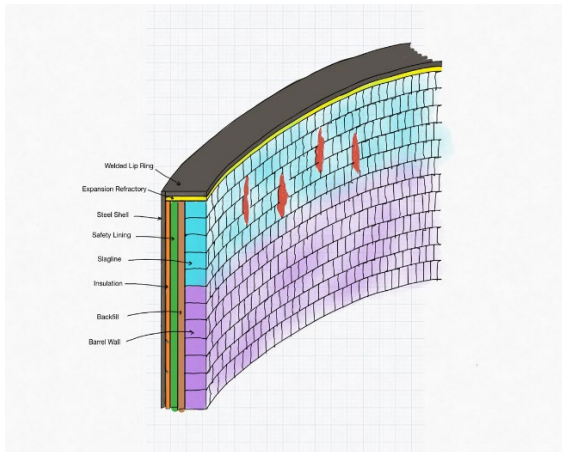
Figure 1- Vertical Cracks in ladle lining

Installation of bricks – joints lined up vertically

Installation of bricks – Loose lining installation

Installation of backfill (when used) – missing section of backfill

Installation of backfill – Backfill not rammed properly and/or not dense enough

Installation of safety lining (no backfill) – missing section of safety lining

Installation of safety lining (no backfill) – Safety lining has major cracks and /or spalled sections and/or repair materials have little integrity (when safety lining used multiple times and repaired)

Excessive thermal Cycling: Low number of heats per day for all days in service

Excessive thermal cycling – Periods of time ladle taken out of service and not used for multiple days (e.g., high heats per day while in service but then out for several days OR worst-case low heats per day and out for

Excessive thermal cycling – No preheating when out of service

Ladle positioning – Ladle is laid on its side for argon plug and slidegate work. Potential for "sagging" of top of lining is high especially if there is any looseness in the lining

Excessive ladle horizontal preheating – When the ladle is on its side AND if you have horizontal preheater AND the preheater has high temperature, long powerful flames - this may cause localized melting, oxidation of joints at the top of the ladle.

Update and/or reinforce installation practices with masonry team to ensure minimal overlap of vertical joints and to ensure tightness of each row of brick by using "wedge" bricks for tightening lining. Visual QAQC check of brick lining when completed.

Update and/or reinforce installation practices with masonry team to ensure proper installation practices including maximum depth of ramming (max 75mm per layer), ramming from top down (no layers that could

spall), integrity of ramming equipment to get required force

Update and/or reinforce installation practices with masonry team to ensure proper installation practices including repair techniques, practices - when to repair with mortar vs plastics/rams vs cast sections vs full bricks.

Meet with steel shop supervisor to explain the phenomenon of low heats per day leads to higher cracking and/or oxidation and thereby cracks and lower life. Optimal is to get ≥ 5 heats/day/ladle in service and to have no periods of time when it is taken out of rotation for >4 hours. A plan for ladle management to achieve this depends on minimum # of ladles in the steel shop as possible without creating a steel plant delay.

Also, for 1.9, is there potential for the steel plant to install ladle covers or "barn doors" to conserve the maximum amount of heat in the ladle between heats? Radiation is T^4 for heat loss and therefore the major factor is heat lost from open top when ladle is empty.

Minimize repair times with long life argon plugs, slidegate plates/nozzles and as soon as repairs done stand the ladle up vertically (and preheat if possible).

Preheater temperature can be optimized (~1400 C - too hot and slag will melt) and/or flame length can be adjusted to shorter flame, so it doesn't impact directly on working lining.

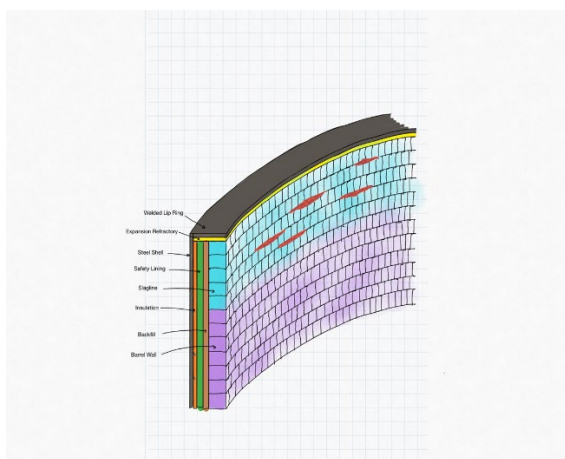
Figure 2- Horizontal Cracks in ladle lining

Installation of bricks – Starting surface of each course not level so gaps between bricks on top of each other

Installation of bricks – Use of mortar in some cases leads to large joints due to creating larger mortar joints that will be quickly worn away

Installation of Lip rings and expansion allowance – Lip rings are no longer horizontal or angled slightly downwards

- **Verification method:** Take a straight edge and measure how "lifted" the front of the lip ring is from the back. If this height lift is >25mm and <74mm then you could be losing compression. If it is >75mm then you will for sure have lost compression and be getting openings on horizontal joints.

Installation of Lip rings and expansion allowance – Bolted lip rings have too much "slop" in the hole they go through and/or the bolts are not tight enough

Installation of monolithic material expansion allowance– Missing section of monolithic material

Installation of monolithic material expansion allowance– Monolithic material has major spalled sections and/or repair materials that have little integrity left and/or major steel penetration of this gap

Excessive thermal cycling in service – Low number of heats per day for all days in service

Excessive thermal cycling in service – Periods of time ladle taken out of service and not used for multiple days (e.g., high heats per day while in service but then out for a number of days OR worst-case low heats per day and out for multiple days)

Excessive thermal cycling in service – No preheating when out of service

Excessive ladle cleaning: Cleaning the ladle lip between heats in the shop with picks, hooks, machines, etc. can cause major damage to the expansion monolithic and/or lift the lip ring system and/or damage to the top course of brick - this can all lead to lack of compression of the working lining and potential for horizontal cracks to open

Overfilling the ladle with steel/slag- If the ladle heat size is not controlled, then the slag and steel can get up to the lip ring and/or monolithic expansion material and do major damage to the integrity of the area.

Update and/or reinforce installation practices with masonry team to ensure each course is horizontal and flat and to ensure tightness of each row of brick. Visual QAQC check of brick lining when completed.

Update and/or reinforce installation practices with masonry team to ensure proper installation practices including that lip ring sits horizontally, welds or bolting system is strong/tight. The rigidity of the lip ring system is the key point to keep the lining in compression and avoiding horizontal joint cracks/wear in the steel ladle. There must be clear criteria as to when to remove a deteriorated lip ring

Update and/or reinforce installation practices with masonry team to ensure proper installation practices (maximum depth for

ramming, plastics to be <75mm for good ramming density) including repair techniques, practices, equipment (is it being rammed properly). If castable is used in the gap, ensure no excess water and/or proper dry out techniques

Meet with steel shop supervisor to explain the phenomenon of low heats per day leads to higher cracking and/or oxidation and thereby cracks and lower life. Optimal is to get ≥ 5 heats/day/ladle in service and to have no

periods of time when it is taken out of rotation for >4 hours. A plan for ladle management to achieve this depends on minimum # of ladles in the steel shop as possible without creating a steel plant delay.

Also, for 2.9 is there potential for the steel plant to install ladle covers or "barn doors" to conserve the maximum amount of heat in the ladle between heats? Radiation is T^4 for heat loss and therefore the major factor is heat lost from open top when ladle is empty.

Prevention of steel "skulls" on the lip of the ladle due to excessive stirring of the ladle can stop the need for excessive cleaning. If cleaning is done, the use of tools and operators with experience to "surgically" remove this material without lifting the ring system and/or damaging the lining are the best way to prevent issues.

Prevention of overfilling the ladle is the only way to stop this mechanism from occurring.

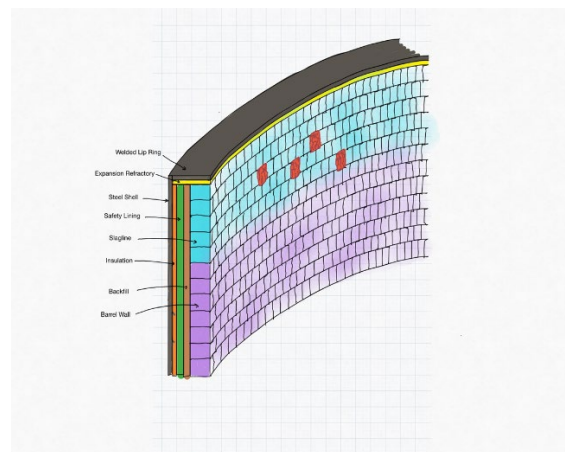
Figure 3- Missing or Worn Individual bricks

Installation of bricks – Loose installation - on a single course the bricks are not installed tightly, and this allows a brick to slip out

Installation of bricks – Backward or Straight - in order to build/finish a course, a brick is installed either backward or a straight brick is used and eventually slips out

Brick quality: wrong type of brick used - for example an AMC brick installed in the slagline, or a dolomite brick installed in slagline.

Brick Quality: Backward or Straight - Poor quality brick originating from supplier - low density, impurities, change in raw materials, etc.

Excessive thermal cycling in service – Low number of heats per day for all days in service

Excessive thermal cycling in service – Periods of time ladle taken out of service and not used for multiple days (e.g. high heats per day while in service but then out for a number of days OR worst case low heats per day and out for multiple days)

Excessive thermal cycling in service – No preheating when out of service

Excessive ladle cleaning: Cleaning the ladle between heats in the shop with picks, hooks, machines, etc can cause major damage to the brick if it is very vigorous and a hole and/or individual brick can be removed and/or extremely damaged

Update and/or reinforce installation practices with masonry team to ensure tightness of each row of brick. Also, ensure all bricks have marking on hot face only so that a backwards brick could be seen. Visual QAQC check of brick lining when completed.

Update and/or reinforce installation practices with masonry team to ensure proper installation practices including a simple, effective system for marking the front faces of bricks with names, shapes, and colors to ensure bricklayers install correctly. For example, slagline bricks could be triangles of different colours and a character to

distinguish. This makes it easy to audit. A system of random tests of incoming brick can also be used but is expensive.

Meet with steel shop supervisor to explain the phenomenon of low heats per day leads to higher cracking and/or oxidation and thereby cracks and lower life. Optimal is to get ≥ 5 heats/day/ladle in service and to have no periods of time when it is taken out of rotation for >4 hours. A plan for ladle management

to achieve this depends on minimum # of ladles in the steel shop as possible without creating a steel plant delay.

Also, for 3.7 is there potential for the steel plant to install ladle covers or "barn doors" to conserve the maximum amount of heat in the ladle between heats? Radiation is T^4 for heat loss and therefore the major factor is heat lost from open top when ladle is empty

Prevention of steel "skulls" on the lip of the ladle due to excessive stirring of the ladle can stop the need for excessive cleaning. If cleaning is done, the use of tools and operators with experience to "surgically" remove this material without lifting the ring system and/or damaging the lining are the best way to prevent issues.
